RSIC-1 ACOUSTIC ASSEMBLY

FCS6 DSWA FIIC 72

Re: **Supplement to DSA Report No 129031-IIC1**
Additional Impact Tests With Floor Covering Samples
DSA File #: 129031

**Concrete Floor With Resiliently Mounted Ceiling
Vancouver Center Apartments, Units 424/324**

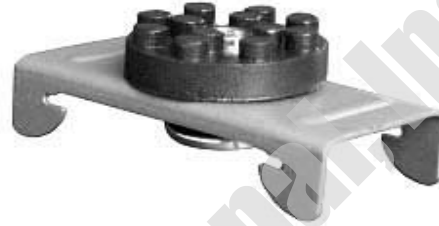
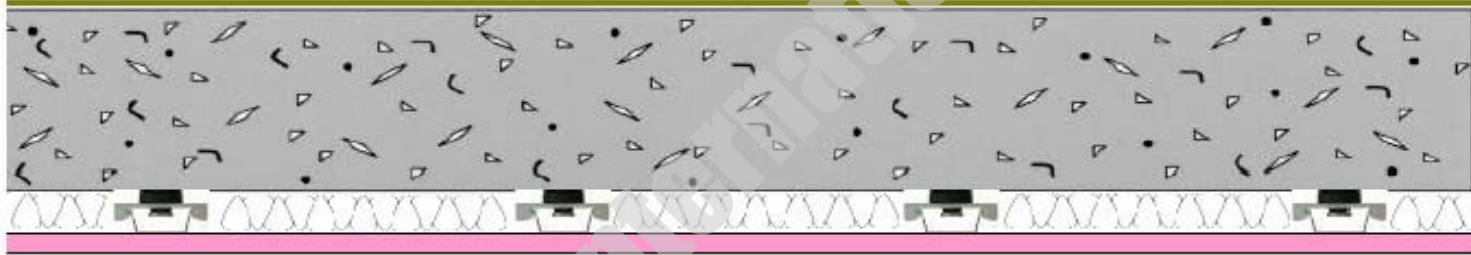
DIRECT FIX TO CONCRETE SLAB

- * Armstrong Cushion Vinyl
- * 8" PT concrete slab
- * R-8 insulation
- * RSIC-1 installed 48" oc.
- * 7/8" furring channel 24" oc.
- * 1 Layers 5/8" Gypsum Drywall

STC 71

FIIC 72

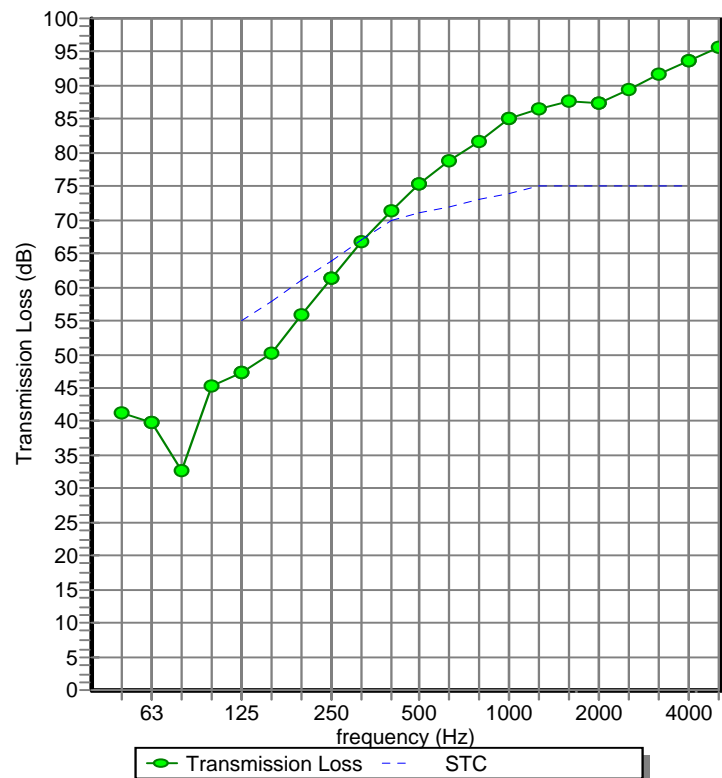
1 x 8.0 in Concrete

$f_0 = 80$ Hz
 1 x 0.6 in Type X Gypsum Board
 thickness 2 in

STC 71
OITC 51

Frequency (Hz)	TL(dB)	TL(dB)
50	41	
63	40	36
80	33	
100	45	
125	47	47
160	50	
200	56	
250	61	59
315	67	
400	71	
500	75	74
630	79	
800	82	
1000	85	84
1250	87	
1600	88	
2000	87	88
2500	89	
3150	92	
4000	94	93
5000	96

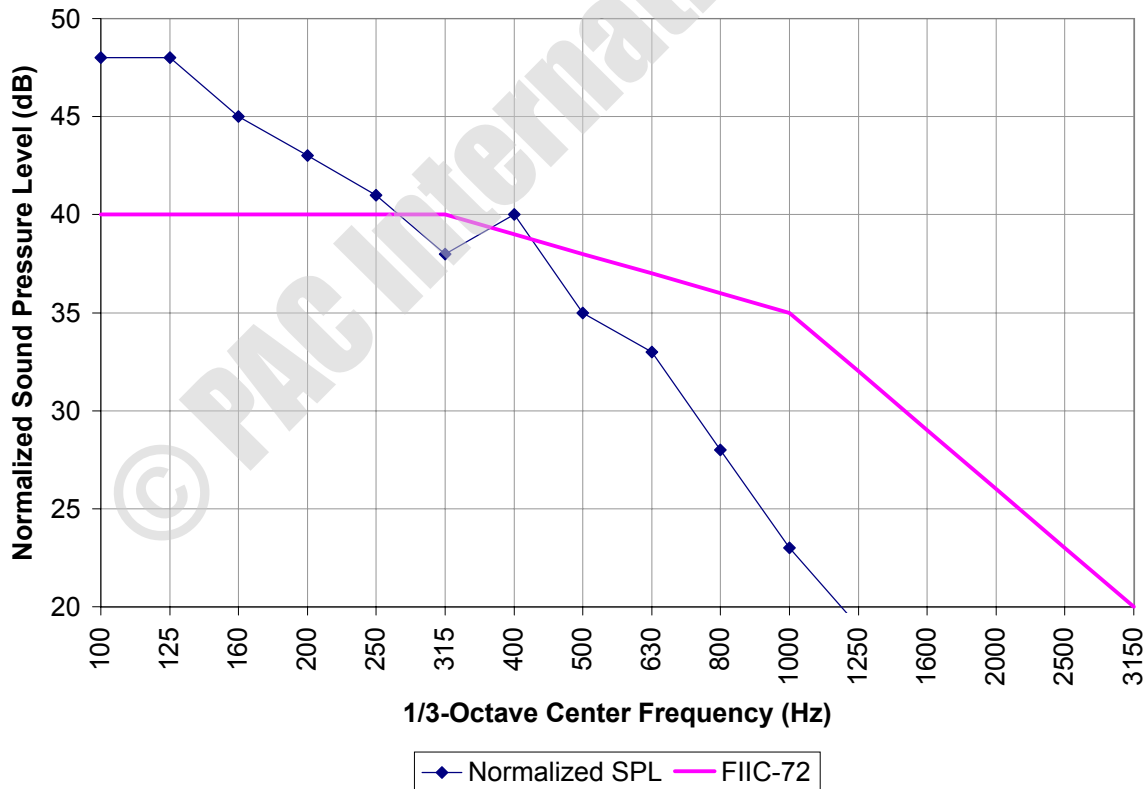
Vancouver Center Apartments - 424/324 - T6 - Cushioned Vinyl

1/3 Octave Center Frequency (Hz)	Normalized Impact SPL (dB)	Deficiency (dB)	Receiving Room Absorption (Sabins)	Notes	1/3 Octave Center Frequency (Hz)	Normalized Impact SPL (dB)	Deficiency (dB)	Receiving Room Absorption (Sabins)	Notes
100	48	8	129	1	630	33	0	42	
125	48	8	66		800	28	0	42	
160	45	5	64		1000	23	0	47	
200	43	3	52		1250	19	0	50	2
250	41	1	49		1600	18	0	54	2
315	38	0	44		2000	17	0	61	2
400	40	1	41		2500	15	0	64	2
500	35	0	39		3150	15	0	61	2
Total Deficiencies = 26					FIIC = 72

Notes: 1. Receiving room volume was less than the ideal value specified in ASTM E1007-97 (6.4) for testing in this frequency band.
 2. Impact noise level in this band was less than 5 dB above ambient. Therefore level indicates only an upper bound of the impact noise level.

Test No	Sample Name	FIIC Equivalent*	Bands in Which Impact Noise Was Less Than 5 dB Above Ambient
1	Base condition (not a sample)	51	none
2	Tile laying on concrete	70*	1000 to 3150 Hz
3	Tile on 5 mm Regupol™	69*	1250 to 3150 Hz
4	Hardwood on 1/16" foam	74*	800 to 3150 Hz
5	Hardwood without foam	72*	3150 Hz
6	Cushioned vinyl on concrete	72*	1250 to 3150 Hz
7	Carpet with pad	87*	All, except 60 Hz
8	Carpet without pad	84*	250 to 3150 Hz
